Apollo One Investigation Materials

Guidance and Control System (GC) - Comments for malfunction procedure

SM2A-03-SC104-(2)
APOLLO OPERATIONS HANDBOOK

G&C
MALFUNCTION

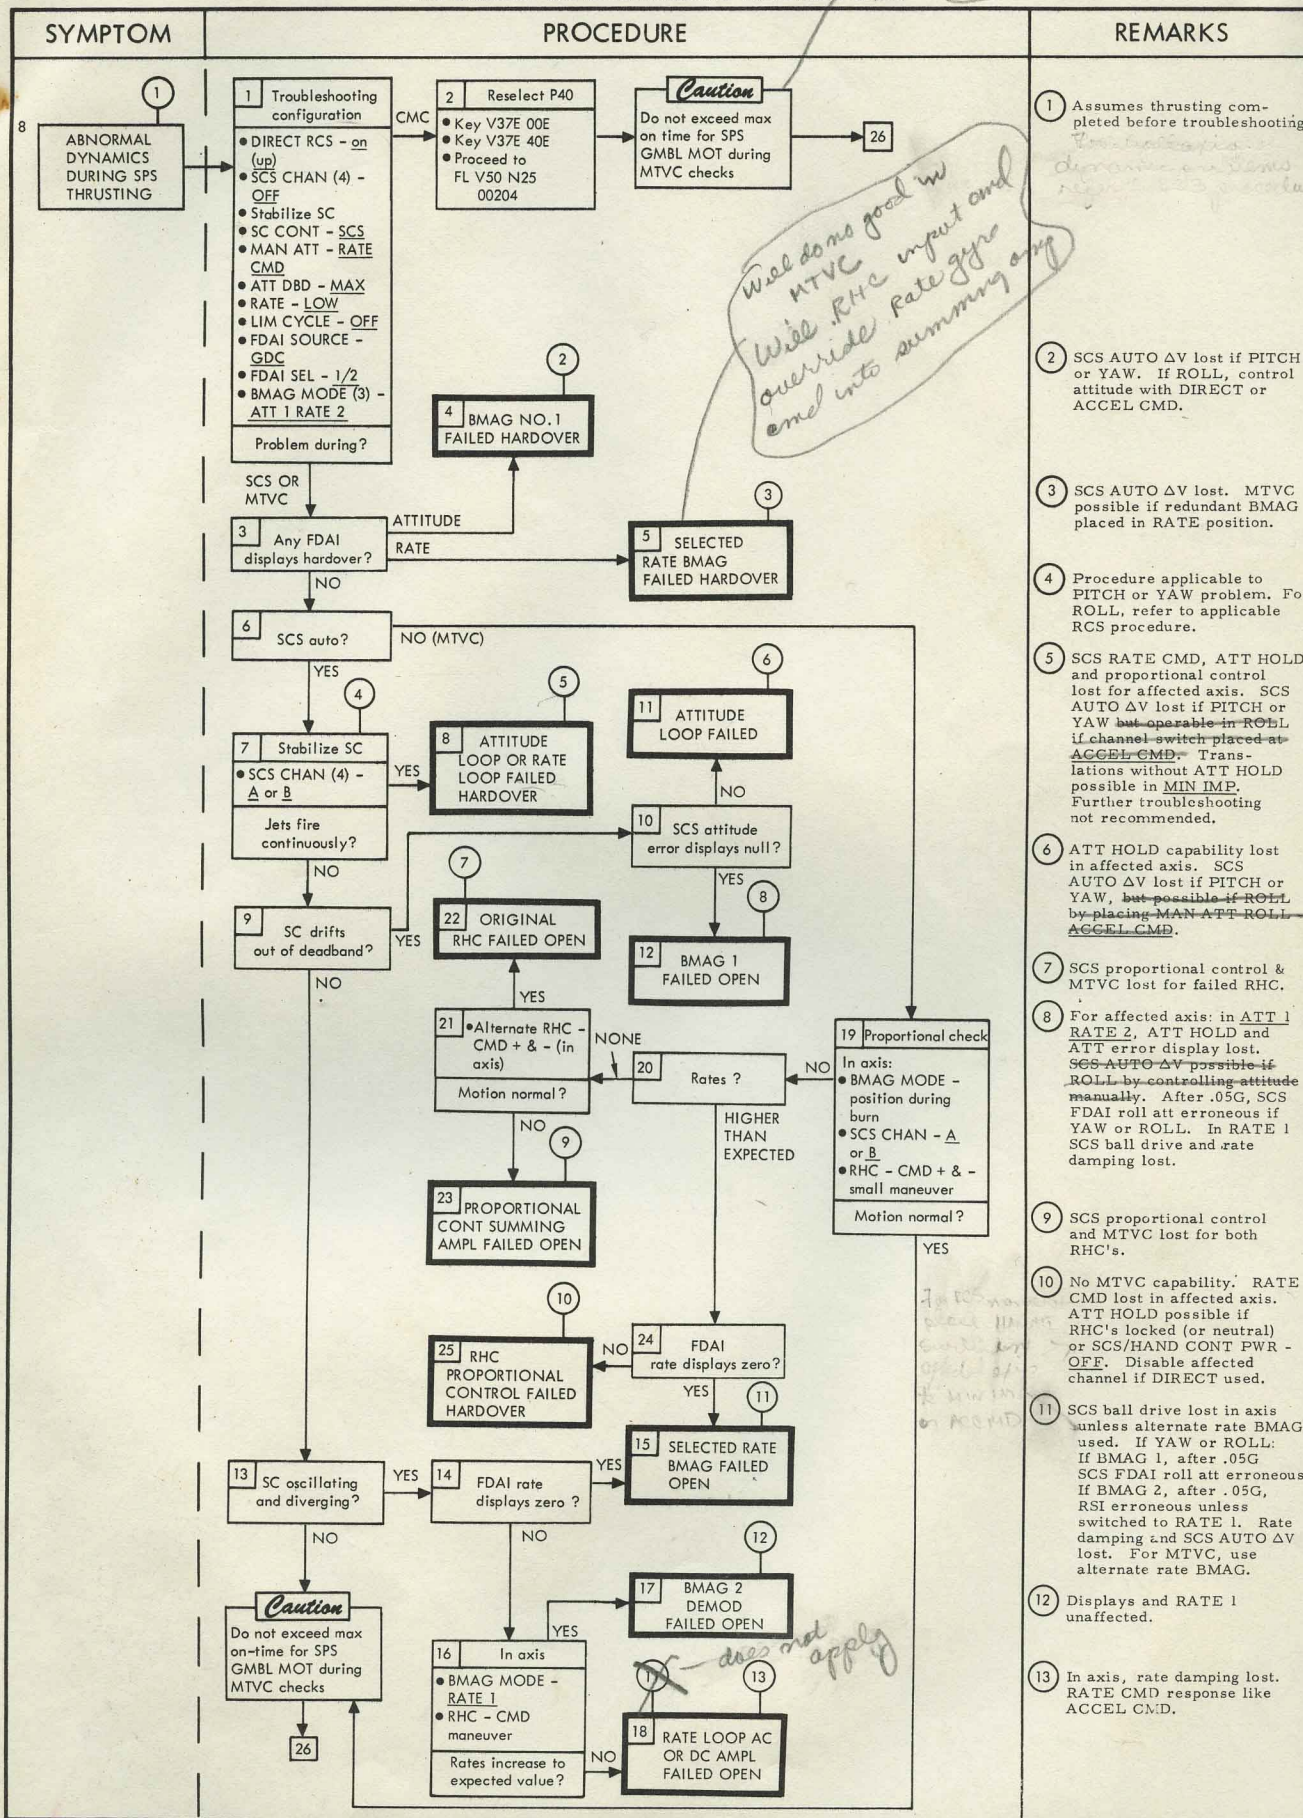
NOTE NOT CLEAR what is max on time?

Will do good in MTVC
Will RHC input and override Rate gyro and into summing amp

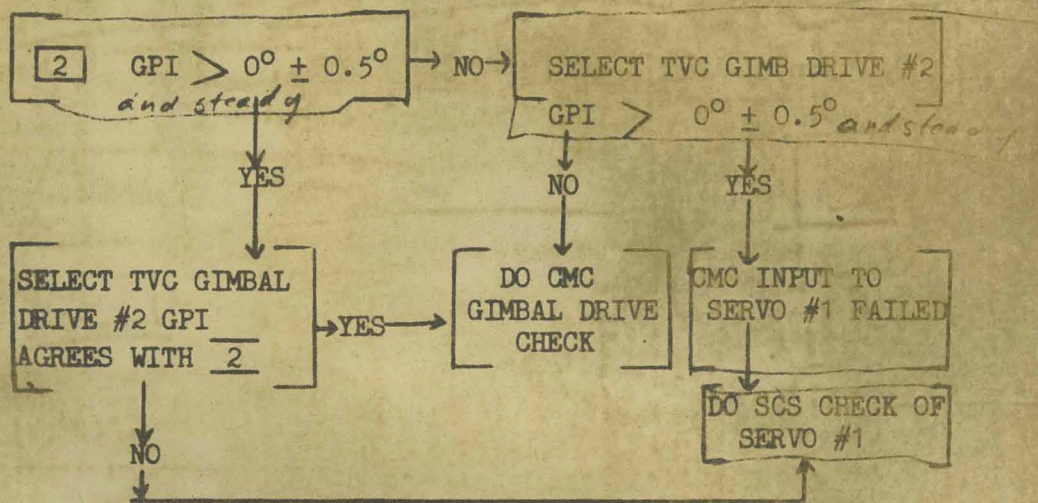
1. CMC SHUT THE BURN OFF
2. CREW SHUT THE BURN OFF THEN EXITED PROGRAM

OTHERWISE THE ERROR COUNTER WILL NOT BE ZEROED AND THE TVC ENABLE WILL NOT BE RESET.

ACTION: REWRITE THIS STEP AS FOLLOWS. ASSUME CMC DID NOT TURN ENGINE OFF, NO CMC OR ISS ALARMS.

EXIT STEP 2 ON SCS

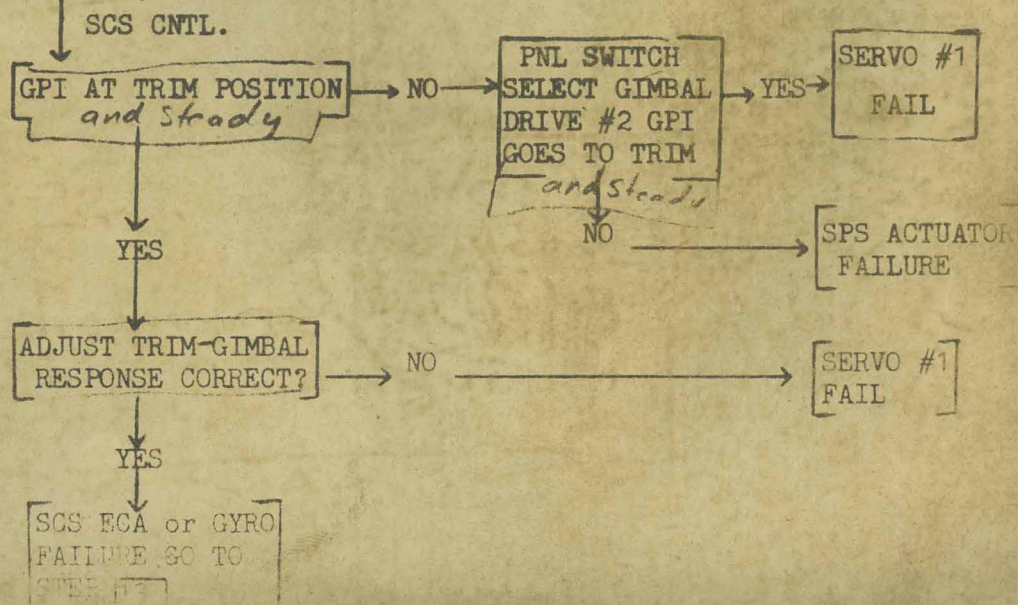
12: THE ONLY TRANSFERABLE ITEM, BETWEEN SCS AUTO AND MTVC RATE, IS A RATE GYRO FAILURE, WHICH CAN ONLY BE DETECTED AFTER ENGINE IGNITION. SINCE, PROBABLY THE ENGINE WOULD BE SHUT DOWN AFTER A FAILURE AND NOT RELIGHTED, THE FAILURE RELATIONSHIP STATED IN 13 DOES NOT EXIST.

13 SHOULD BE CHANGED AS FOLLOWS:

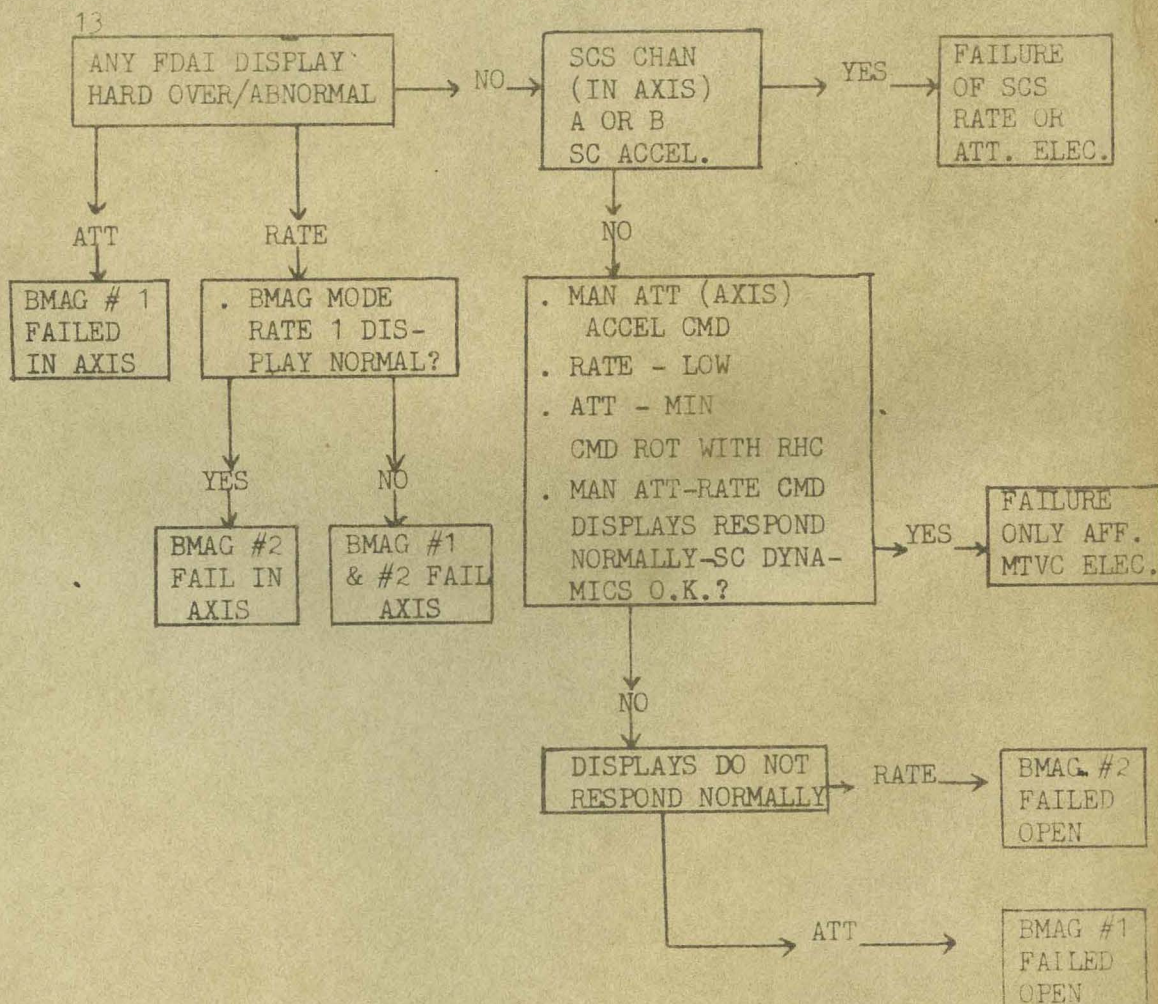
G&C

- 1 FDI RATE IND. ABNORMAL

Should select a...
the display.
